Smoke and Dye Testing Summary

High Level Sewershed

Run Summary

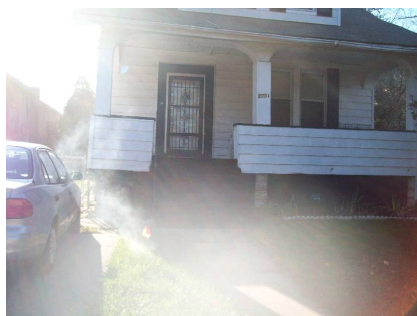
Picture \S1028-137-OB01-P01.jpg

Source Cleanout

Location Yard - front

Comments Smoke from cleanout in front yard. 2701 Belvedere Ave.

Comments Front of house, 2701 Belvedere Ave.

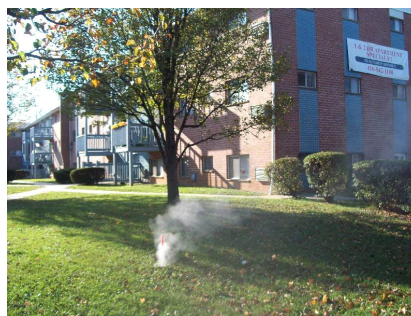
Picture \S1028-137-OB02-P01.jpg

Source Cleanout

Location Yard - front

Comments Smoke from cleanout in front yard of apartments. 2607 Belvedere Ave.

Comments Front of apartments, 2607 Belvedere Ave.

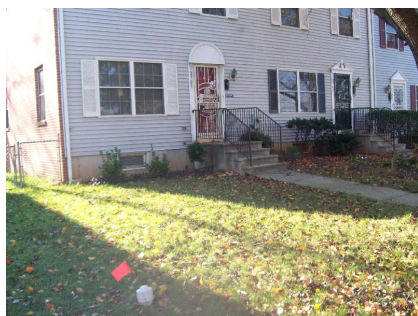
Picture \S1028-137-OB03-P01.jpg

Source Cleanout

Location Yard - front

Comments Smoke from cleanout in front yard. 2705 Belvedere Ave.

Comments Front of house, 2705 Belvedere Ave.

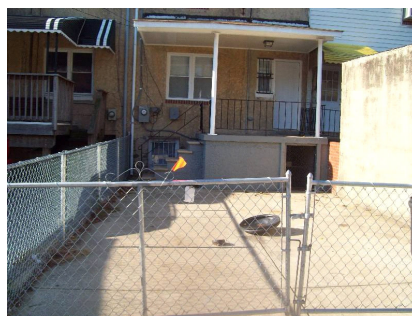
Picture \S1028-137-OB04-P01.jpg

Source Cleanout

Location Yard - back

Comments Smoke from cleanout in back yard. 5105 Pembridge Ave.

Comments Back of house, 5105 Pembridge Ave.
